2013 Operations, Maintenance, and Monitoring Report

East Mud Lake Marsh Management (CS-20)

State Project Number CS-20
Priority Project List 2

September 2013
Cameron Parish

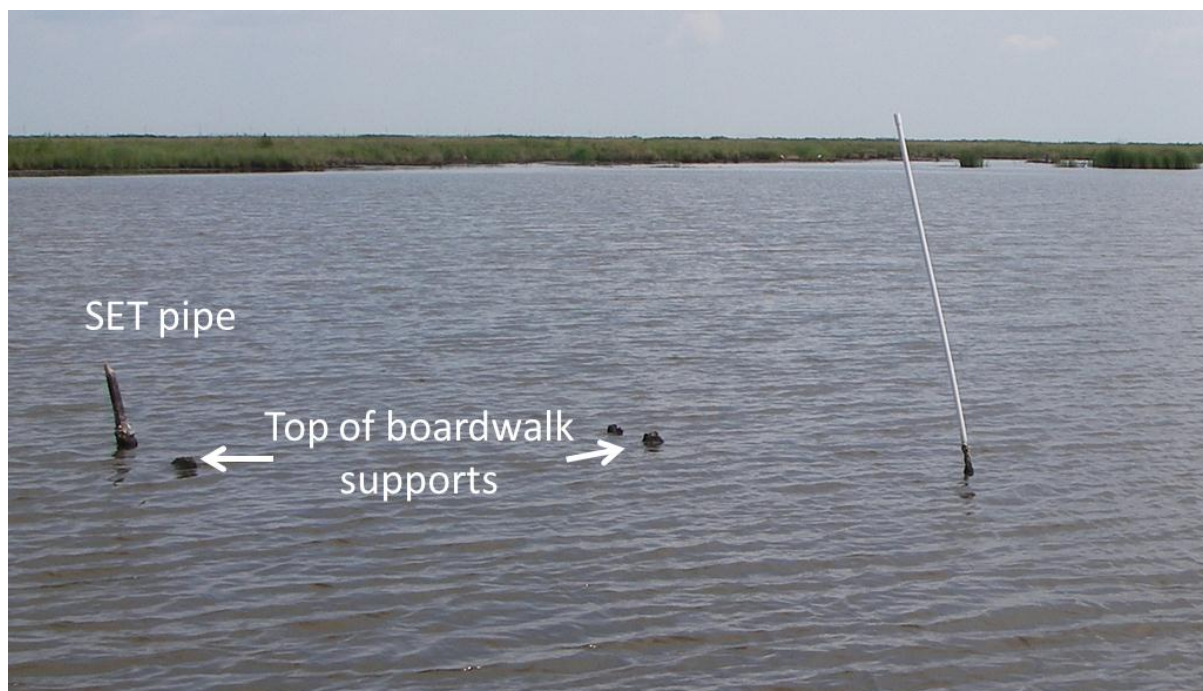
Picture 1. Picture of Station CS20-52R taken in Aug 2009 following Hurricanes Rita (2005) and Ike (2008). Most of the open water was marsh prior to the hurricane storm-surge scour (see figure 4 for extent of damage in Reference Area 1).

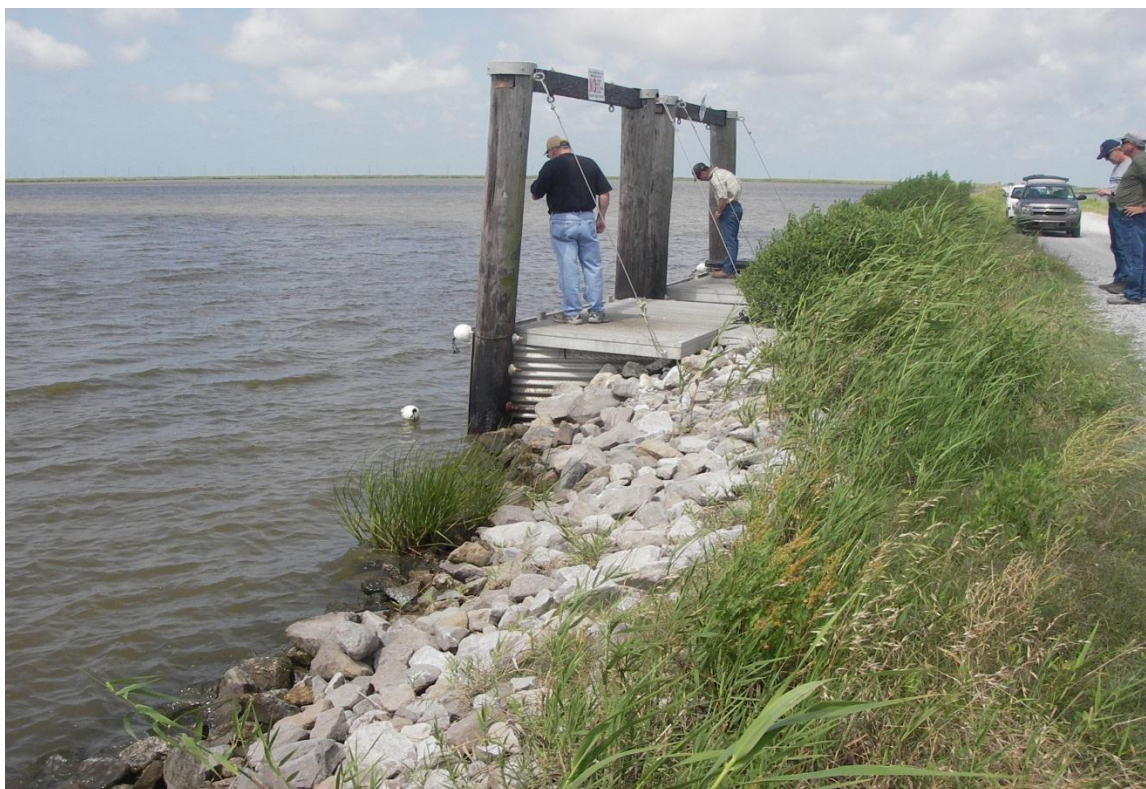
Photo No.1 Structure No. 6

The condition of Structure No. 6 is very good. The timber piles, stop logs, grating, etc. are in good condition. (Photos: Appendix A, Photo 1).

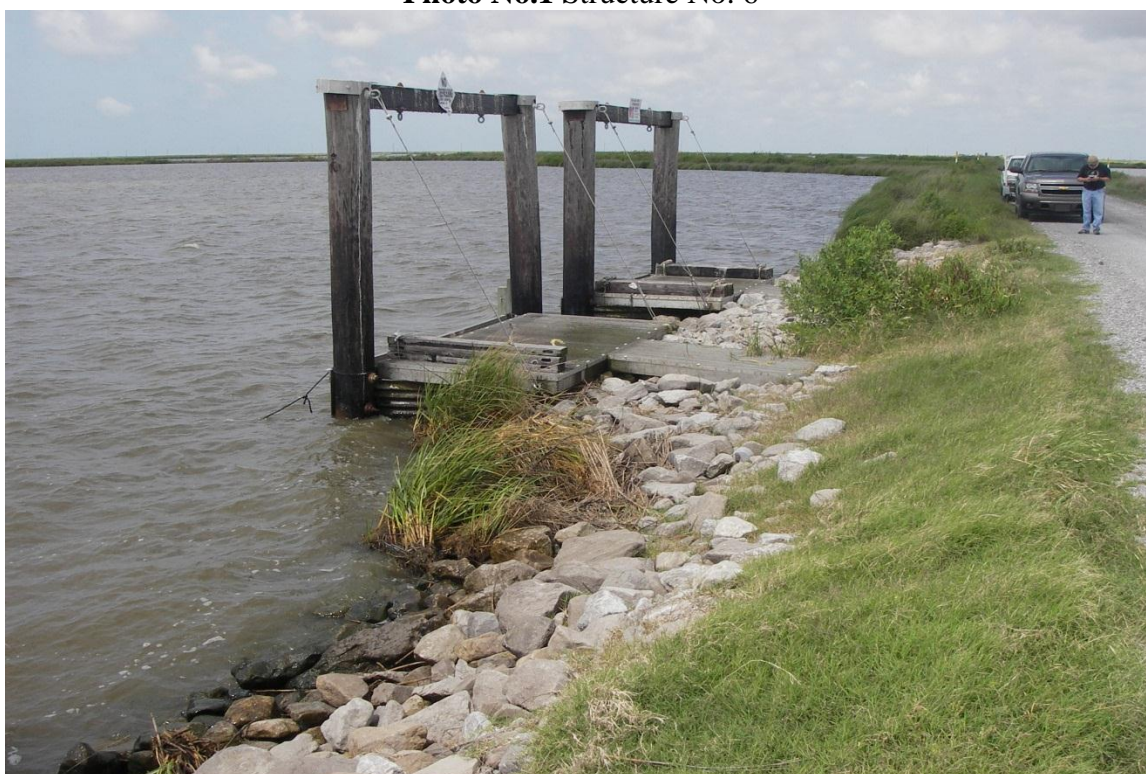
Photo No. 2 Structure No. 7

Structure No. 7 is also in very good condition. The timber piles, stop logs, grating, etc. are in good condition. (Photos: Appendix A, Photo 2).

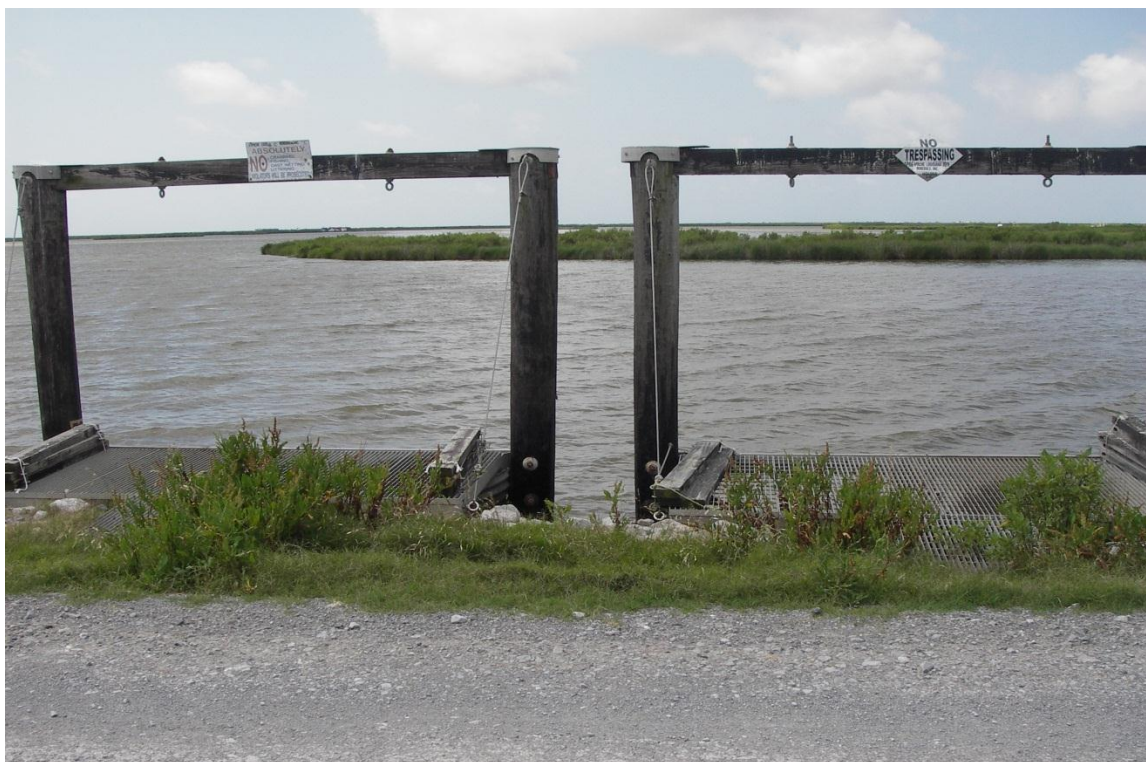
Photo No. 3, Structure No. 8

Structure No. 8 is in very good condition. The timber piles, stop logs, grating, etc. are in good condition. (Photos: Appendix A, Photo 3).

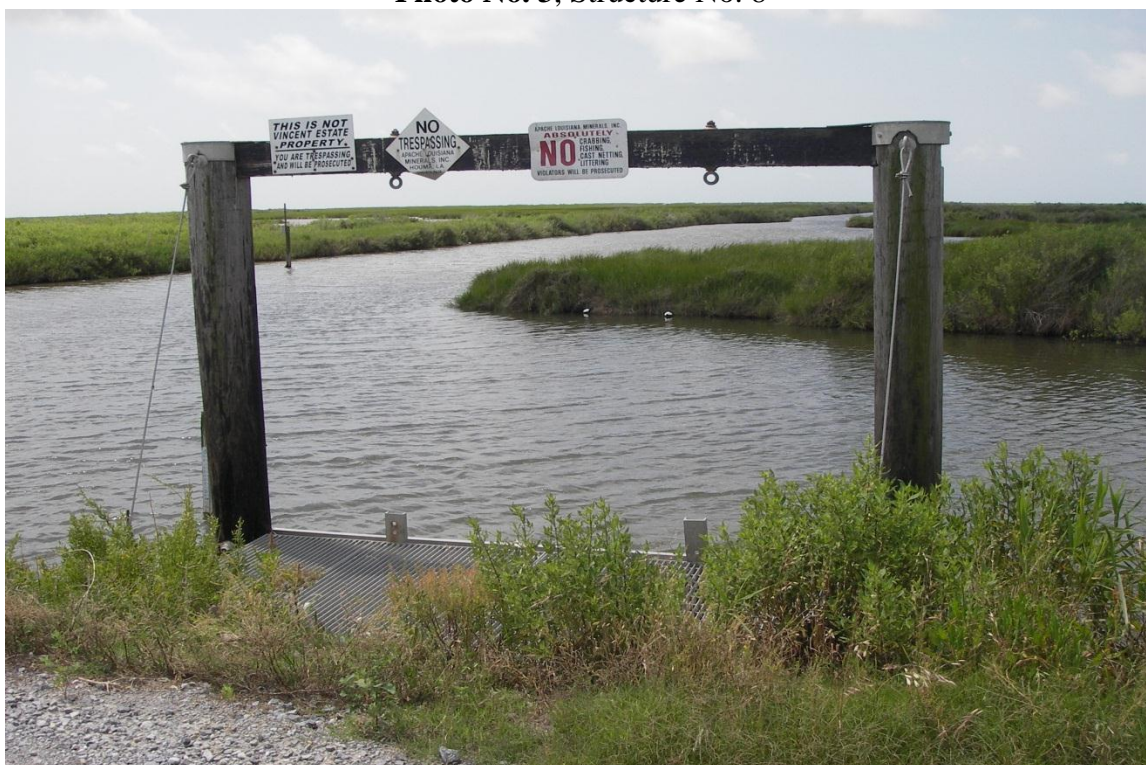
Photo No. 4, Structure No. 9a

Structure No. 9a is in good condition and functioning as intended. (Photos: Appendix A, Photo 4).

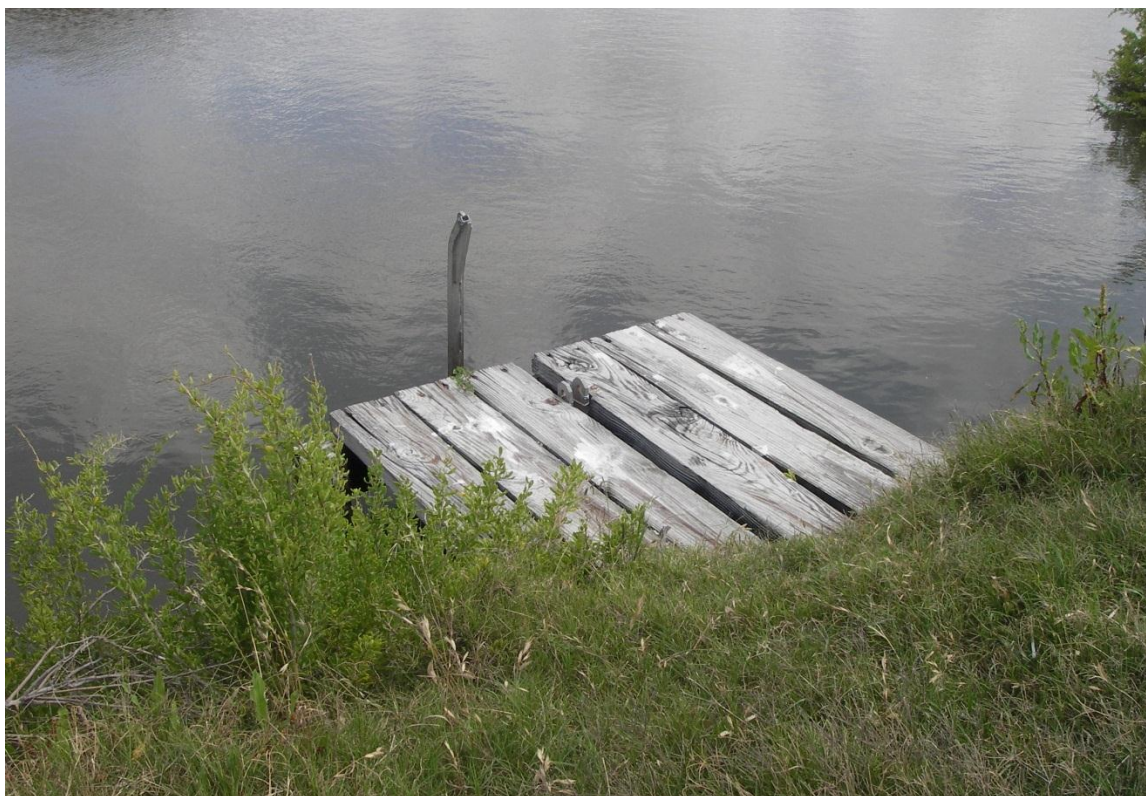
Structure No. 9b is in good condition. Vandals have broken the flapgate lifting arm. Apache has filed a police report. The structure is still functional and all other components are in good shape. (Photos: Appendix A, Photo 5).

Photo No. 5, broken lifting arm on Structure 9b

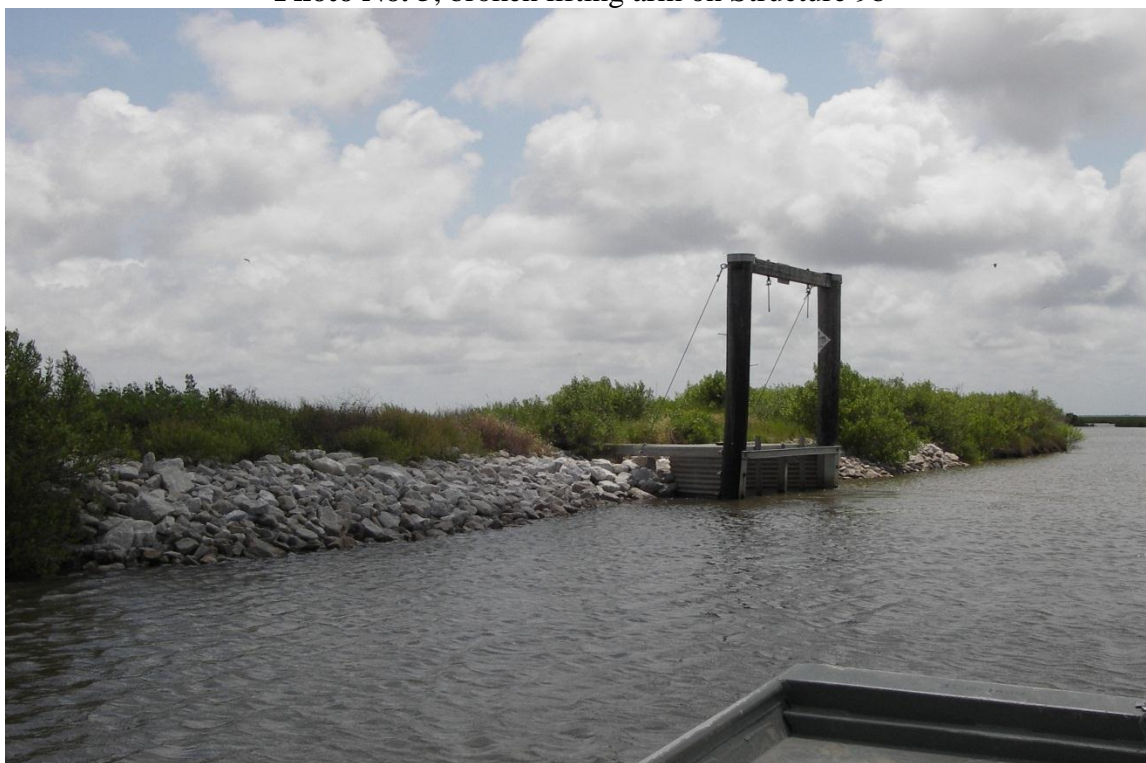
Photo No. 6, Structure No. 11

The structure is in good condition. Rock has stabilized the bank on both sides of the structure. Vandals had blocked open the flap, but no other damage was done. (Photos: Appendix A, Photos 6 & 7).

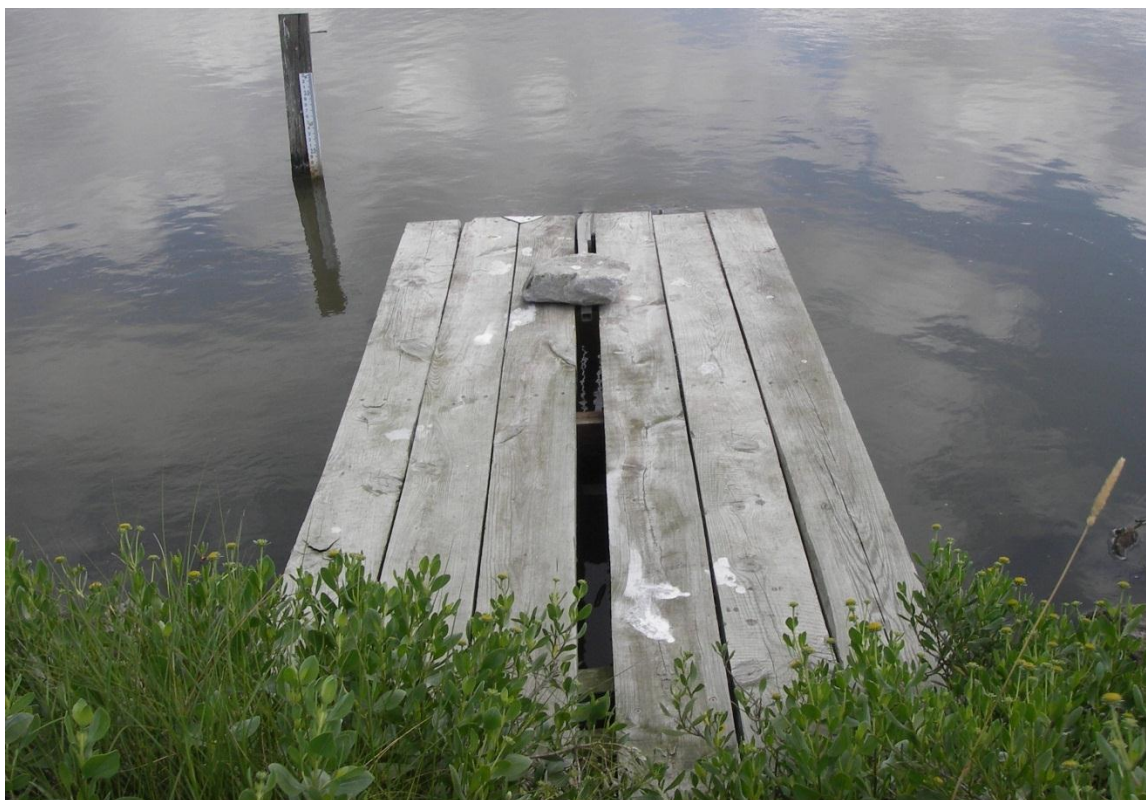
Photo No. 7, flap chocked open, Structure No. 11

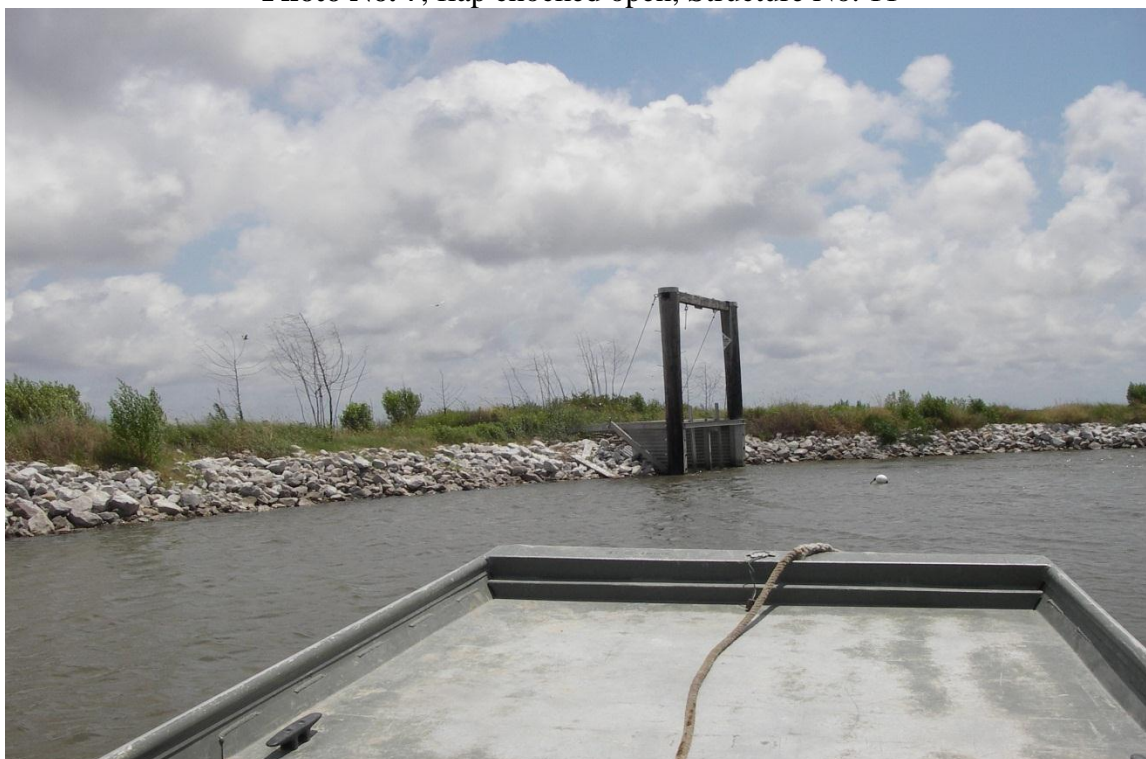
Photo No. 8, Structure No. 5

The structure itself is in good condition. Rock placed here has worked very well also. Vandals had blocked open the flap, but no other damage was done. (Photos: Appendix A, Photo 8 - 10).

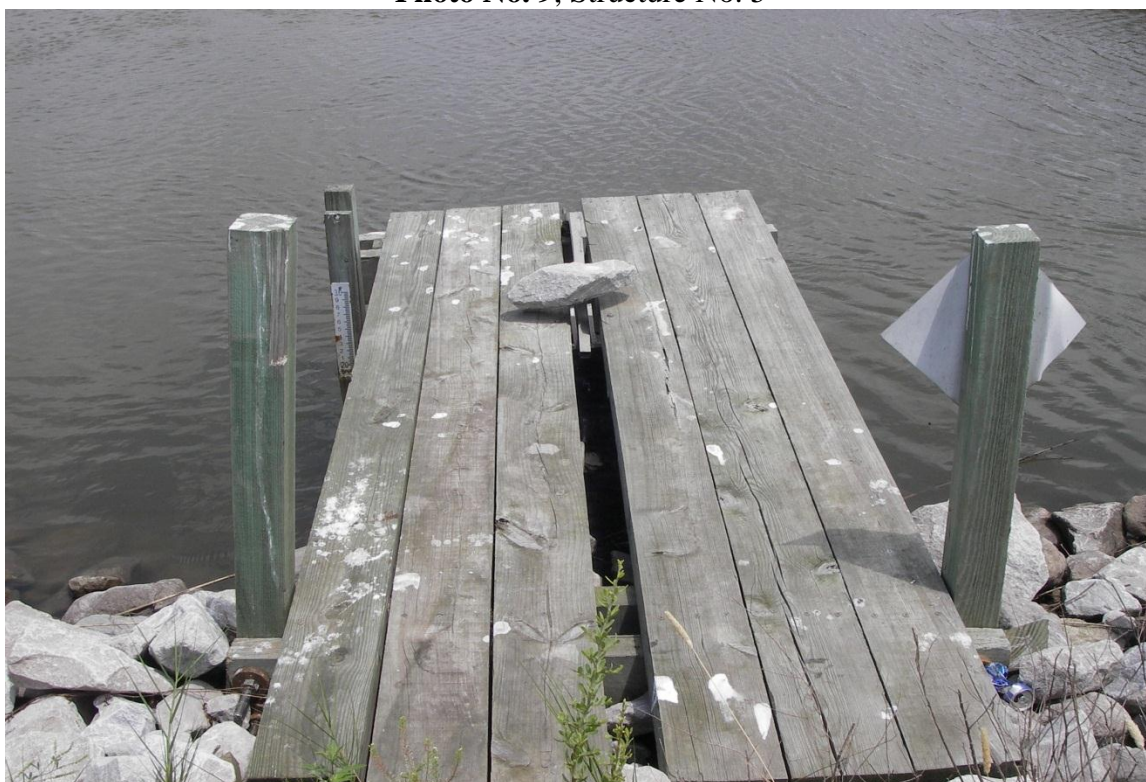
Photo No. 10, flap chocked open, Structure No. 5

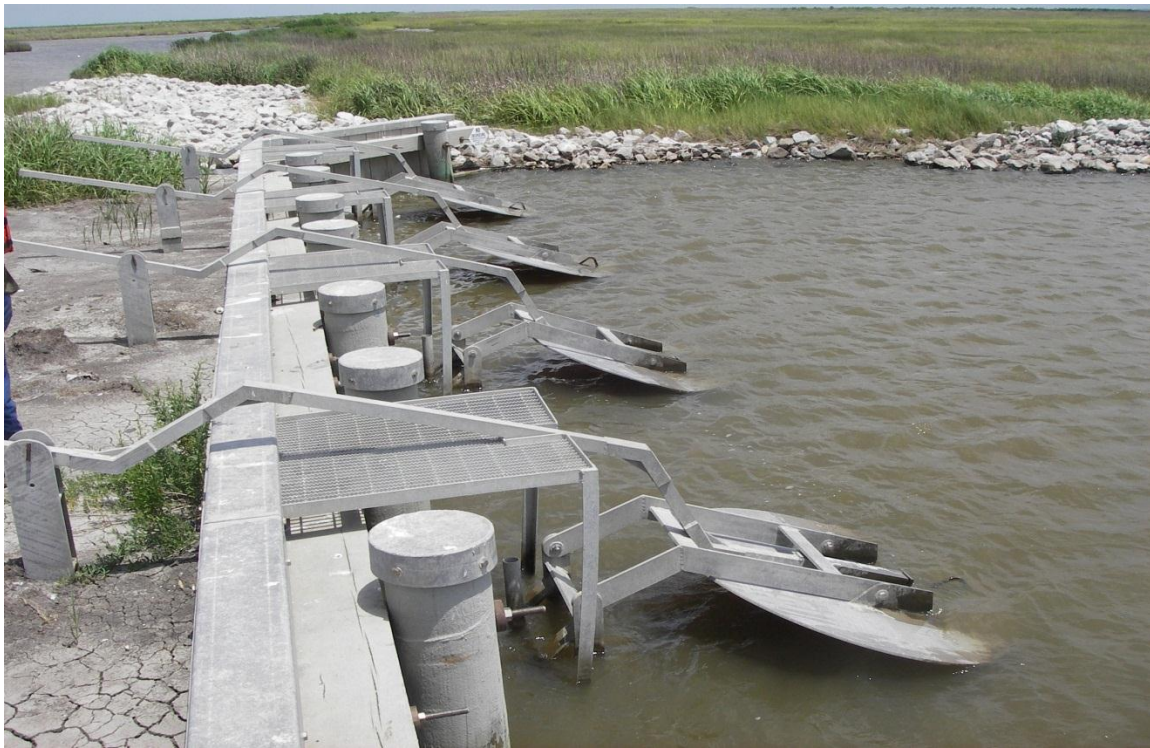
Photo No. 11, flap side, Structure No.4

This structure was completely replaced with a new 48 inch diameter five barrel drainage structure, including timber supports, and rock armoring. The pre-existing structure No. 4 was abandoned in place by driving steel sheet piles through the mid-section of the culverts. Vandals have stolen locks, stoplog locking devices and stoplogs. They have placed their own locks on some of the bays. They have also cut, and replaced with their own, one of the boards on the boat barrier that was installed on the lake side of the project area. Police reports have been filed. The dirt placed on top of the new structure has settled significantly and will be monitored. Sinkholes have developed on the stoplog side of the structure and have gotten worse. They will continue to be monitored. (Photos: Appendix A, Photos 11 - 14).

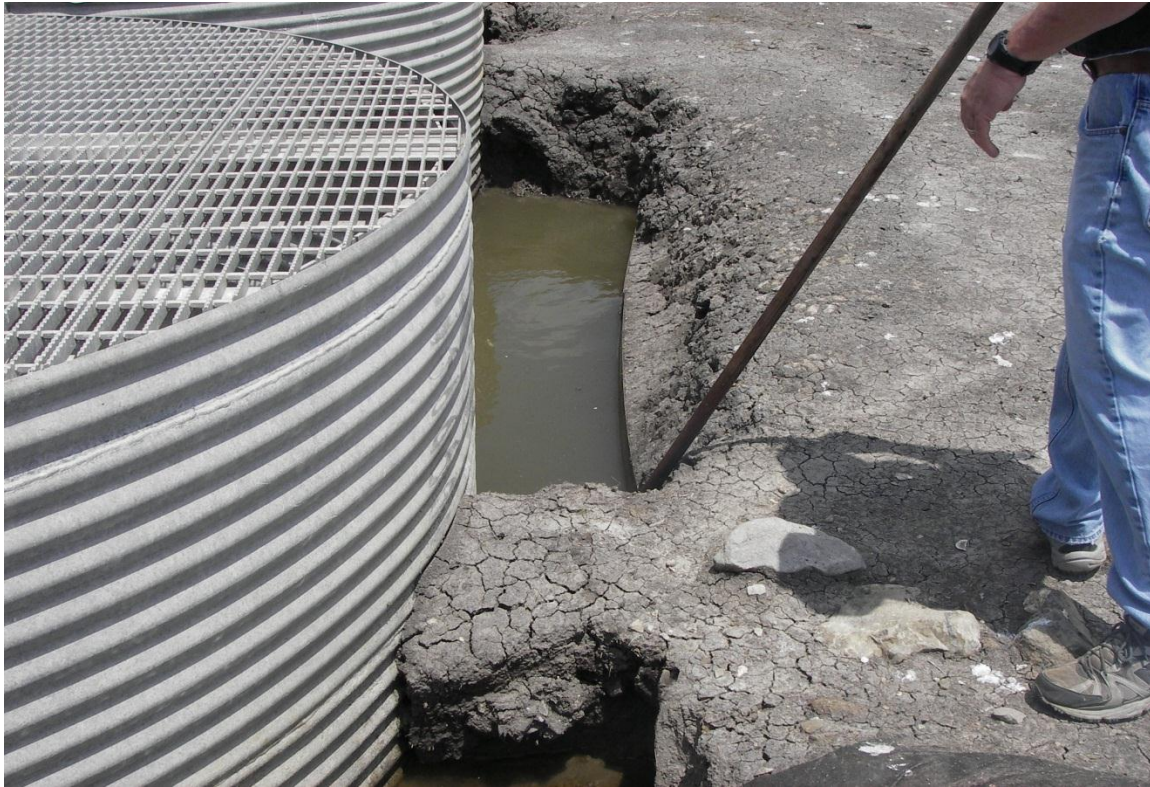
Photo 14, sinkholes developing behind Structure 4 stoplog bays

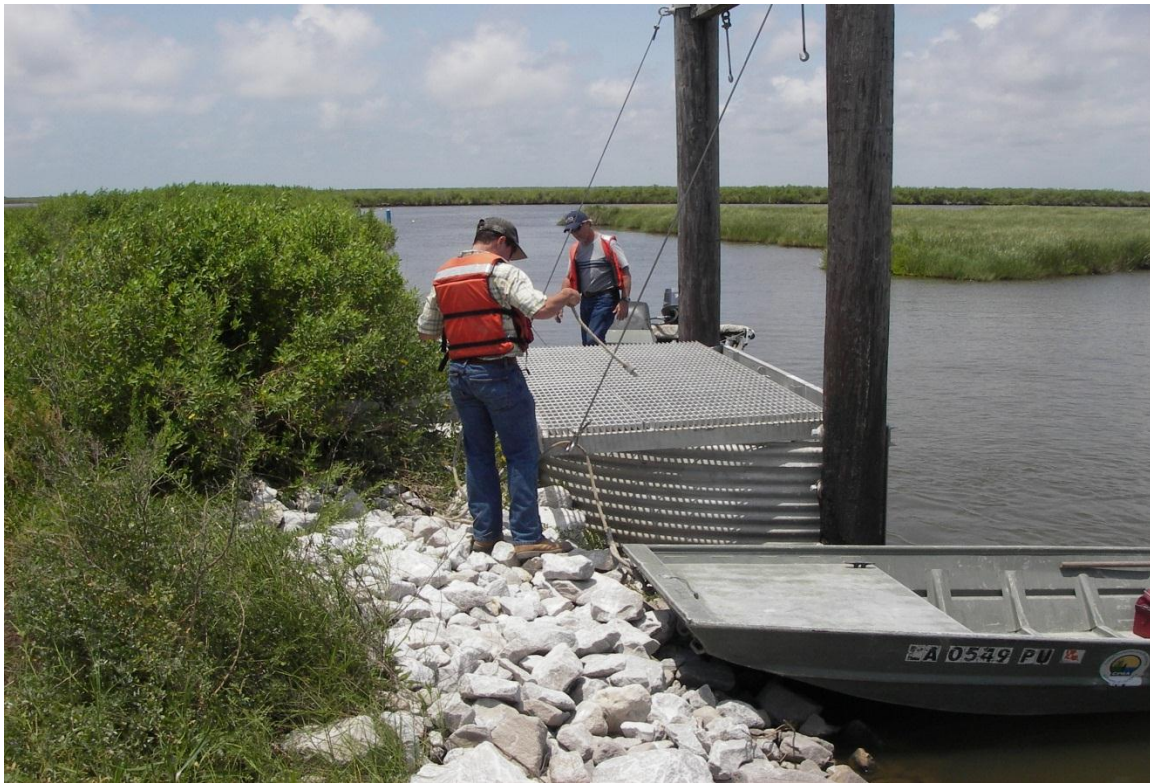
Photo 17, Structure 1

This structure is in good condition. Walkways have been tacked into place. No vandalism at this structure. Rock has stabilized the banks. (Photo: Appendix A, Photos 17 & 18).

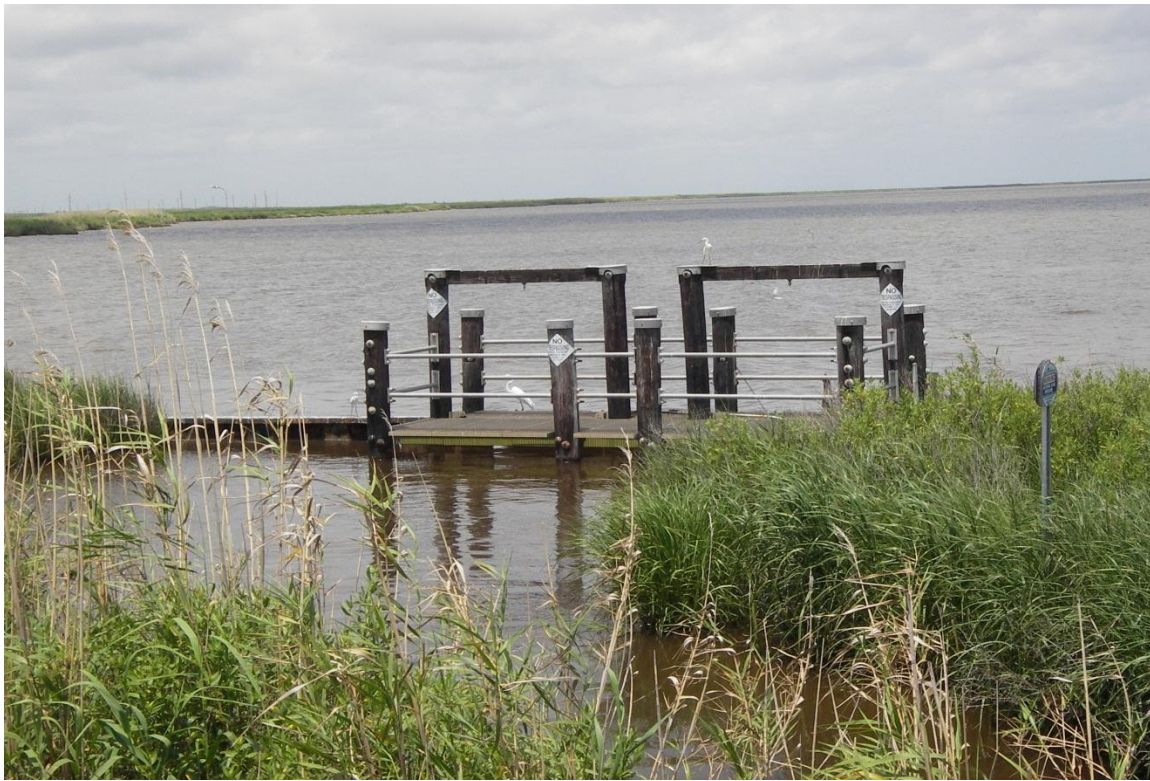
Photo 19, Structure 13

This structure is in very good condition. Flow is now possible through the structure. (Photos: Appendix A, Photos 19 & 20).
